Topfield TF5800PVR Power Supply Repair

This page provides an account with photographs of my repair to the power supply on my Topfield TF5800PVR, known to owners as a 'Topsy'. This was my first attempt at anything like this, and so I recorded the steps in order to give encouragement to anyone else who might be considering doing the same thing.

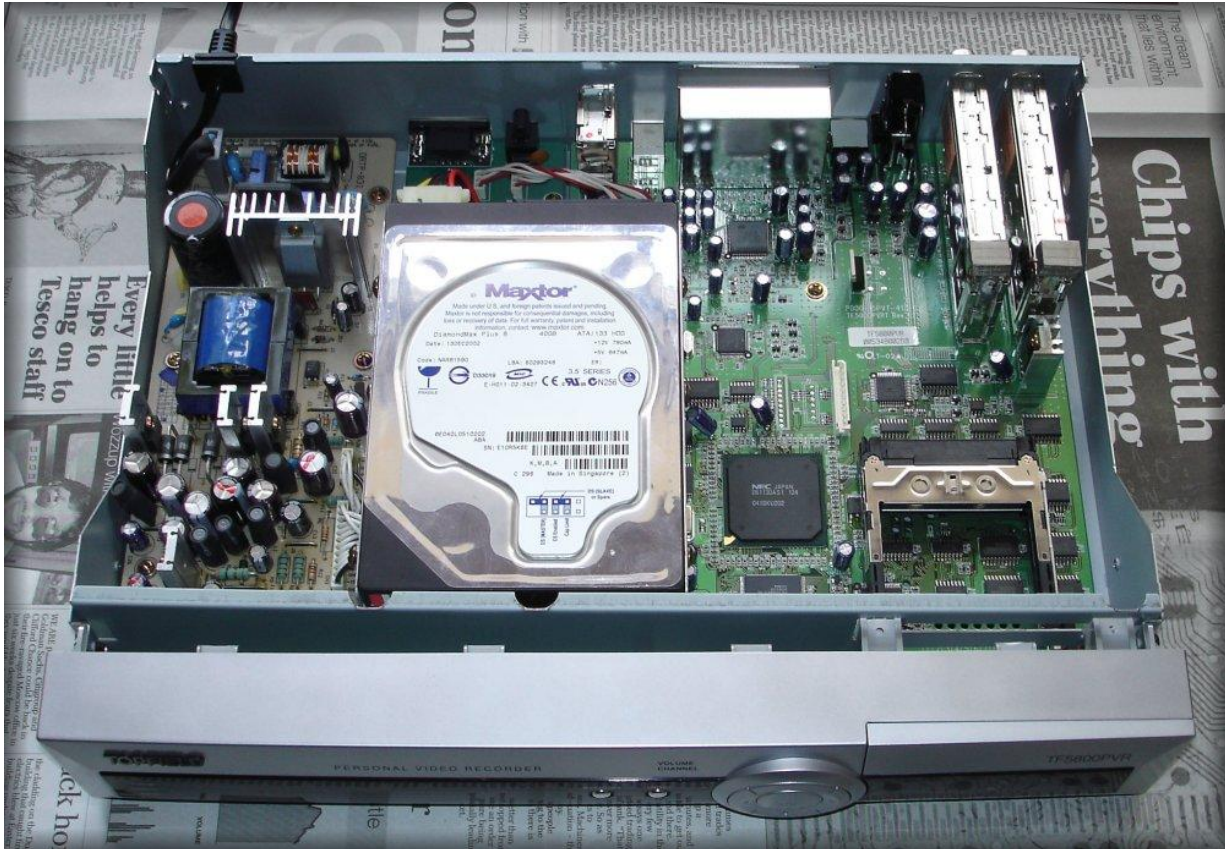
Cover off

The cover is held on by five screws - one on each side and three on the back. First time in you have to break a seal that invalidates the warranty. No problem on a four year old box.

You can see the power supply on the left, then the hard drive centre-left, then the main circuitry on the right. The top-up TV slots are bottom right, and the aerial sockets top right.

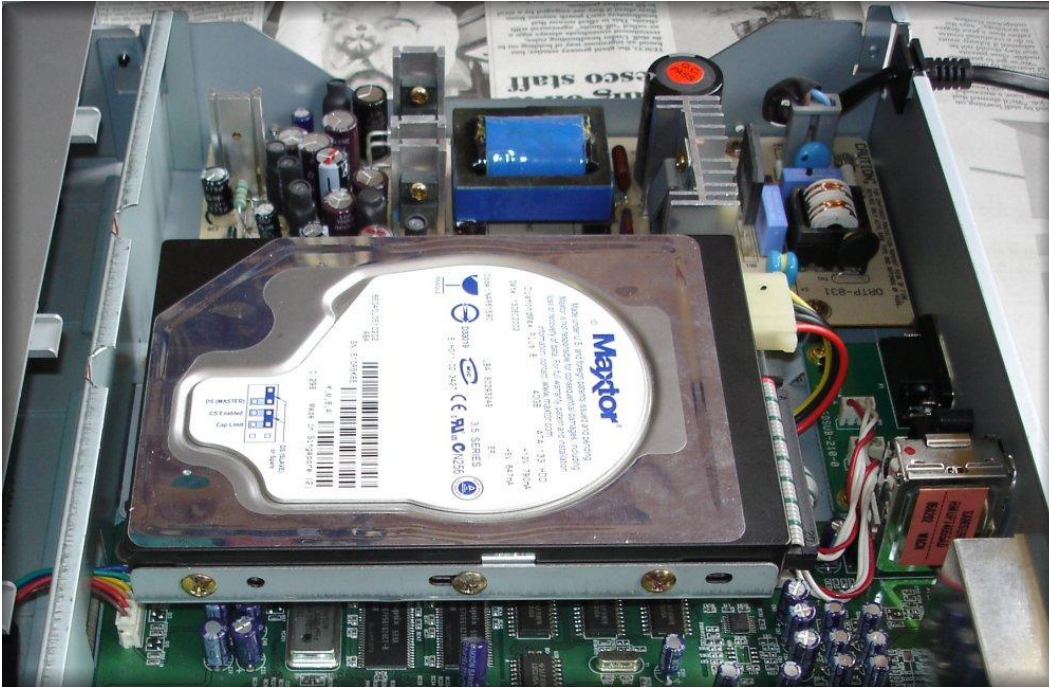
Hard drive fixings

You can see three screws on the facing side of the hard drive in this photo. There are three on the other side as well. A long screwdriver helps get a better angle on these.

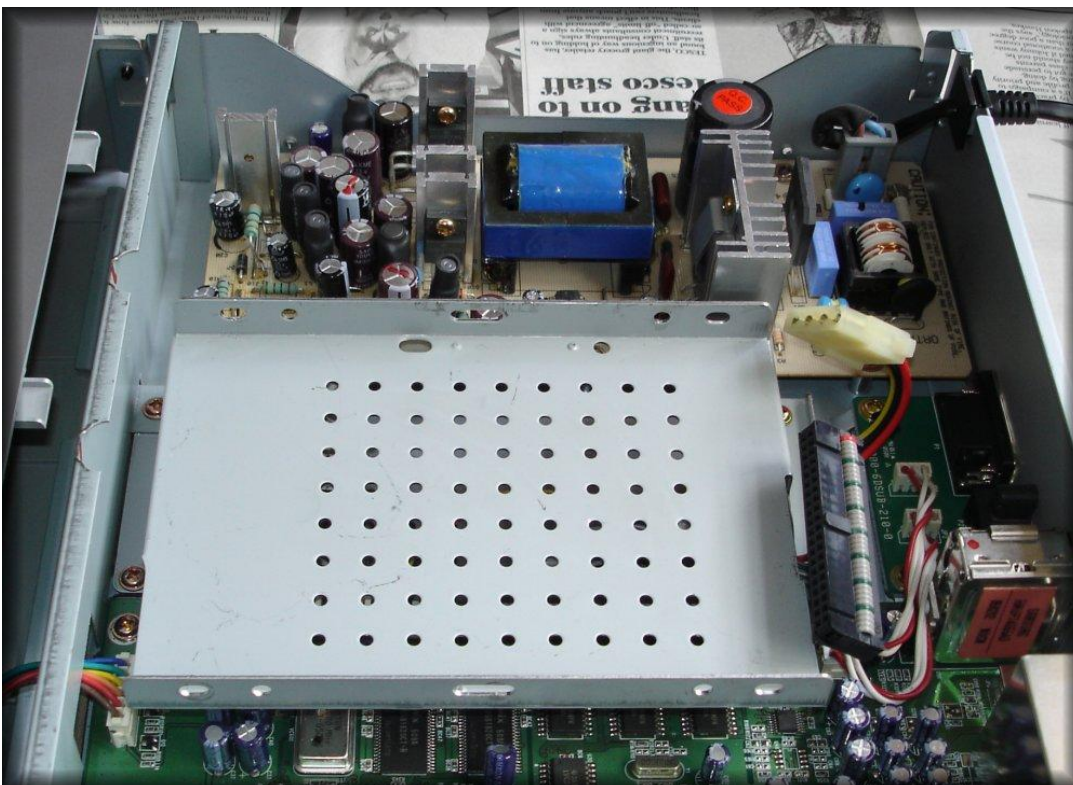
Hard drive removed

With the hard drive removed the molex and IDE connectors are clearly seen. Next the hard drive bay comes out to give access to the connections from the power supply.

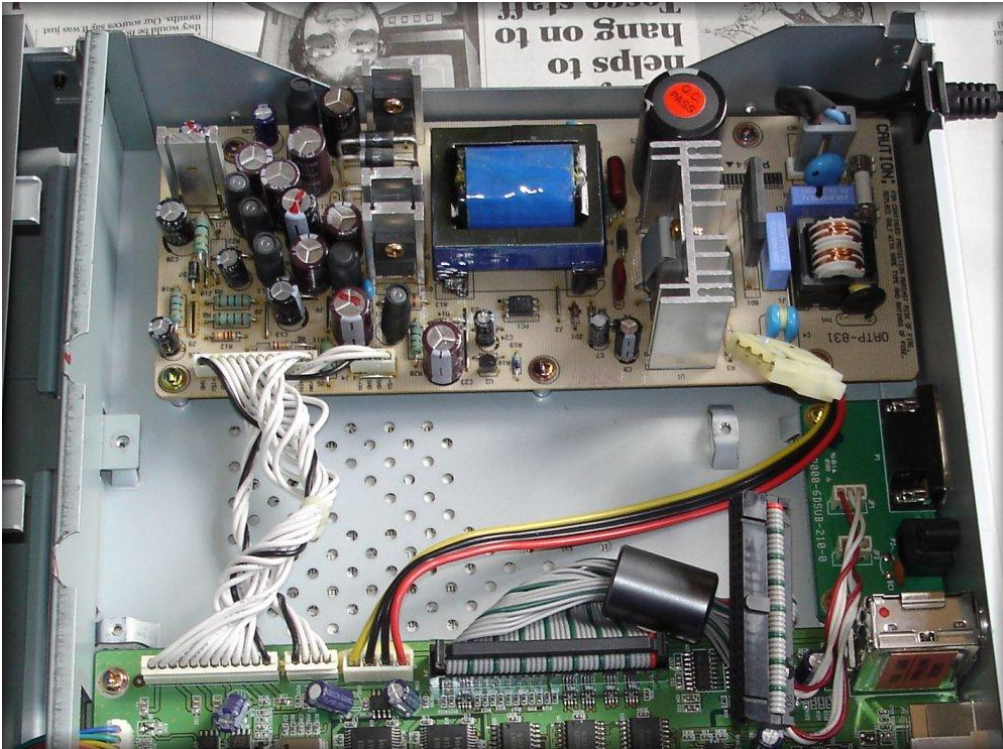
Power supply leads

At first glance the leads from the power supply to the main circuit board look like they might unplug from the power supply board, but the plugs are actually on the main circuit board.

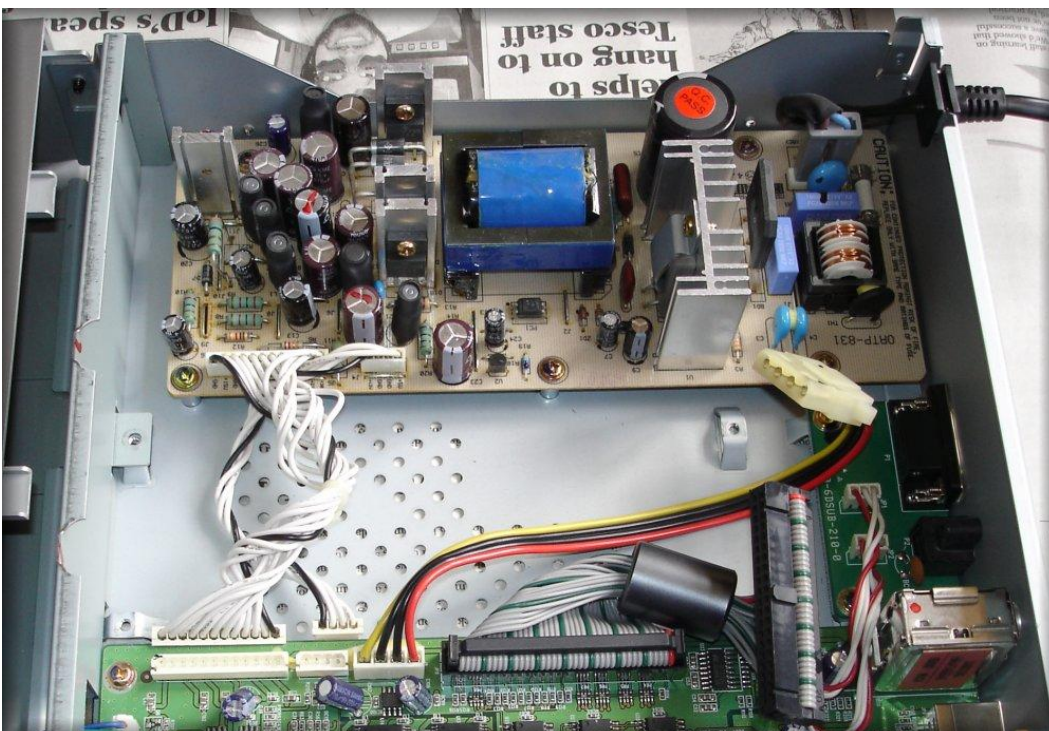
Power supply leads unplugged

This photo shows the power leads unplugged from the main circuit board. Now the power supply can be removed by unscrewing the board at the mounting points. The screws on the near side of the board are clearly visible.

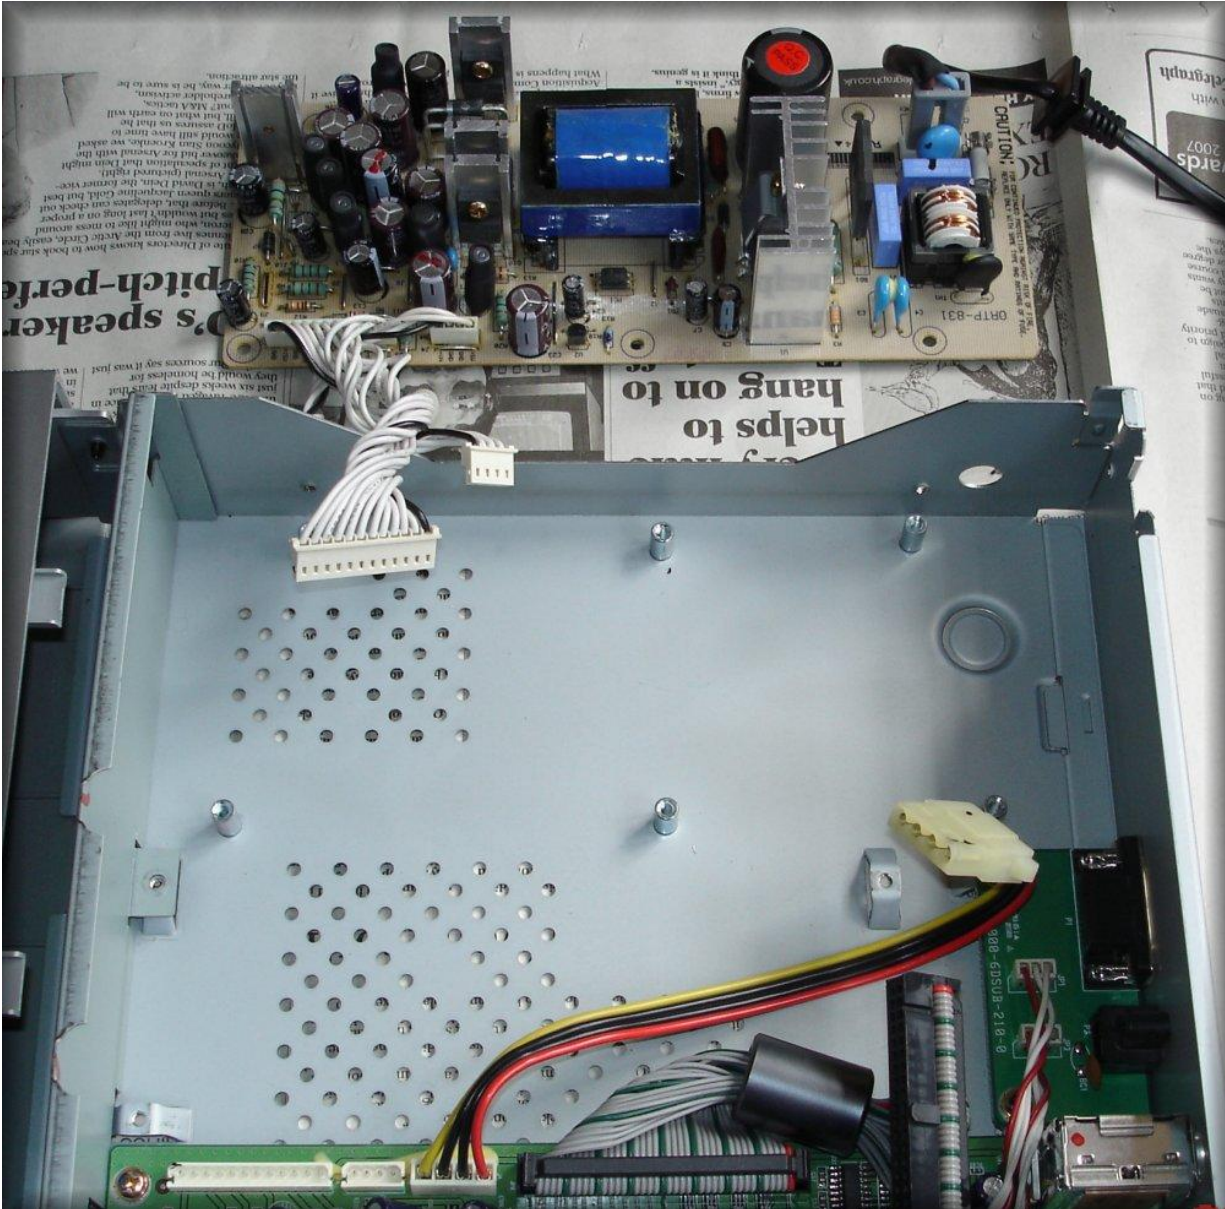
Power supply removed

The easy bits are all done. The job has only taken ten or fifteen minutes so far. Now for some soldering.

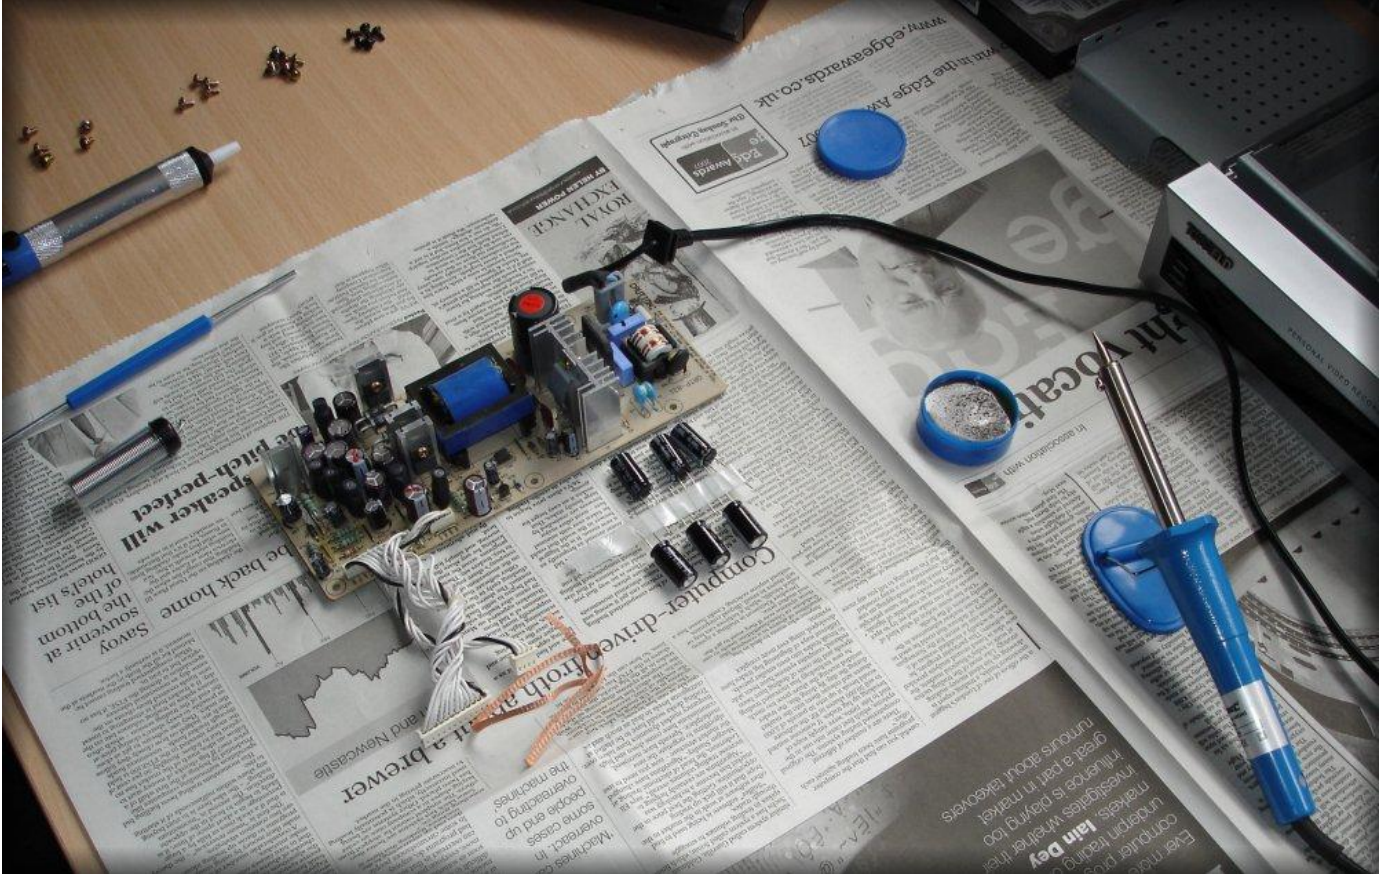
Preparing the work area

With the chassis out of the way just the bits needed are left. The new capacitors are lying next to the power supply board. The copper coloured ribbon is copper braid which MikeyP provided with the capacitors. More on that in a bit.

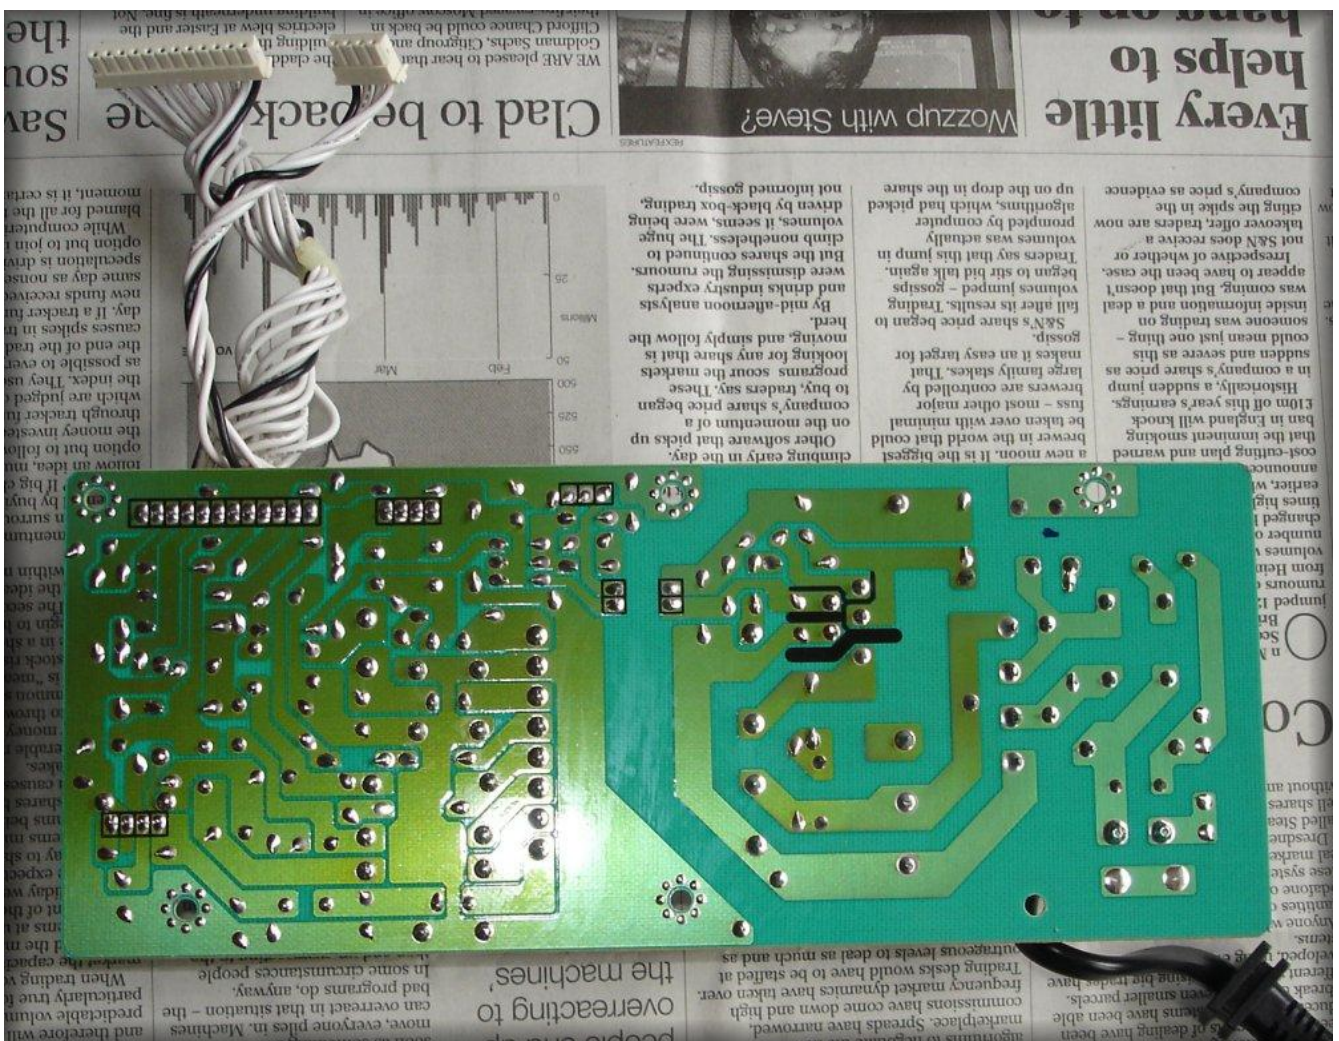
Soldering

This is the underside of the power supply board. As you can see, there is little to identify what's what. Care is needed to identify the connections for the capacitors to be replaced. It isn't too difficult as you turn the board over to match up the connections, but you certainly don't want to rush it. I used a fibre pen to mark the negative connection for each of the six capacitors.

MikeyP had given me the circuit board identification numbers for the six capacitors to be replaced. However, with some of the centrally positioned capacitors the labelling on the board is slightly ambiguous. Fortunately, on one of the Toppo forums I found a link to a [detailed picture with each of the capacitors clearly marked](#). Polarity of the capacitors is important. The capacitors MikeyP supplied had negative markings on the side with the shorter wire, as did the originals. The circuit board also identifies the polarity with a bold semicircle around the negative connection point.

I can't show you pictures of the soldering itself as it isn't advisable to solder with one hand and take pictures with the other, and my attractive assistant was busy walking the dogs! The copper braid worked very well in removing the existing solder. By placing this on the connection and then the iron on the braid the solder was drawn into the braid as it heated to melting point. Even so, this was the trickiest part of the operation. I very carefully straightened the connectors if they were bent over and eased the capacitors out one by one. On one I had to have a second go at removing the solder before it would come out.

Inserting and soldering the new capacitors was a doddle by comparison. Taking great care to insert the connectors into the circuit board holes the right way round, simply bending the connectors over held the new capacitor in place firmly enough to solder. I held the tip of the iron against the connector at the connection point, and then offered the solder to the connector wire. After a few seconds the solder would run and form a neat ball around the wire. Before each connection I touched the iron in my flux to help prevent oxidation and to help the solder run. Finally, the excess connector wire is snipped off once the solder has cooled.

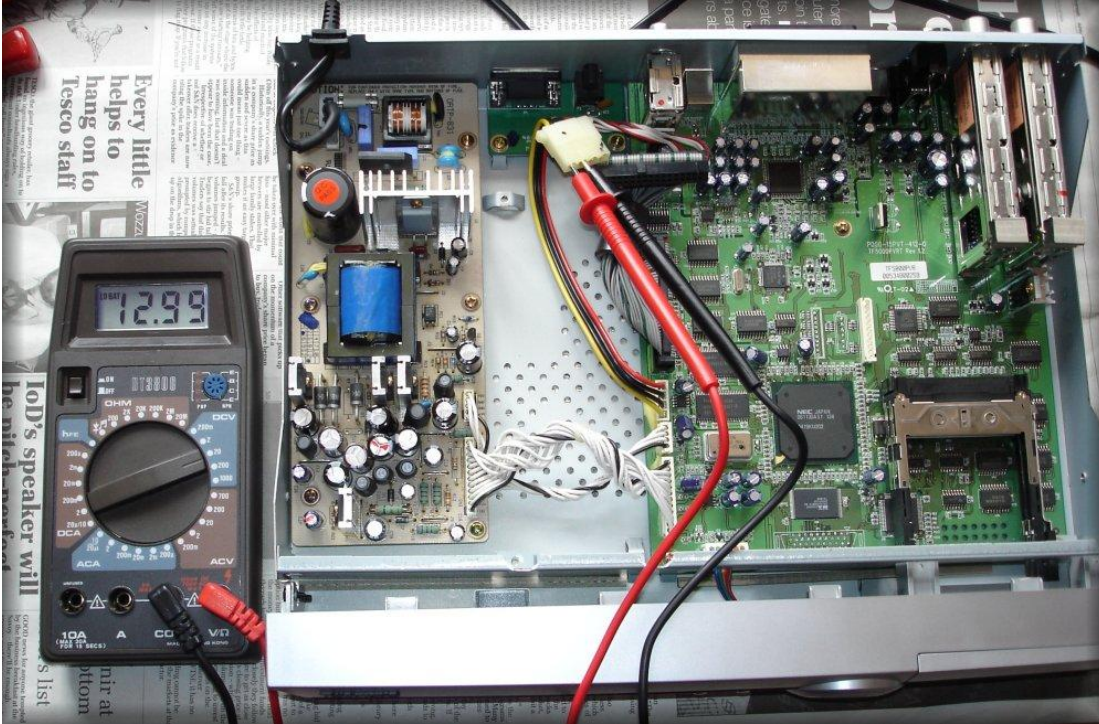
Time to test - 12v

With the board back in place it was time to test the voltages again. The 12v is still slightly high. Doubtless some gurus on the Toppo forums will tell me why this might be. Still, 12.99v is a lot better than 14.98v.

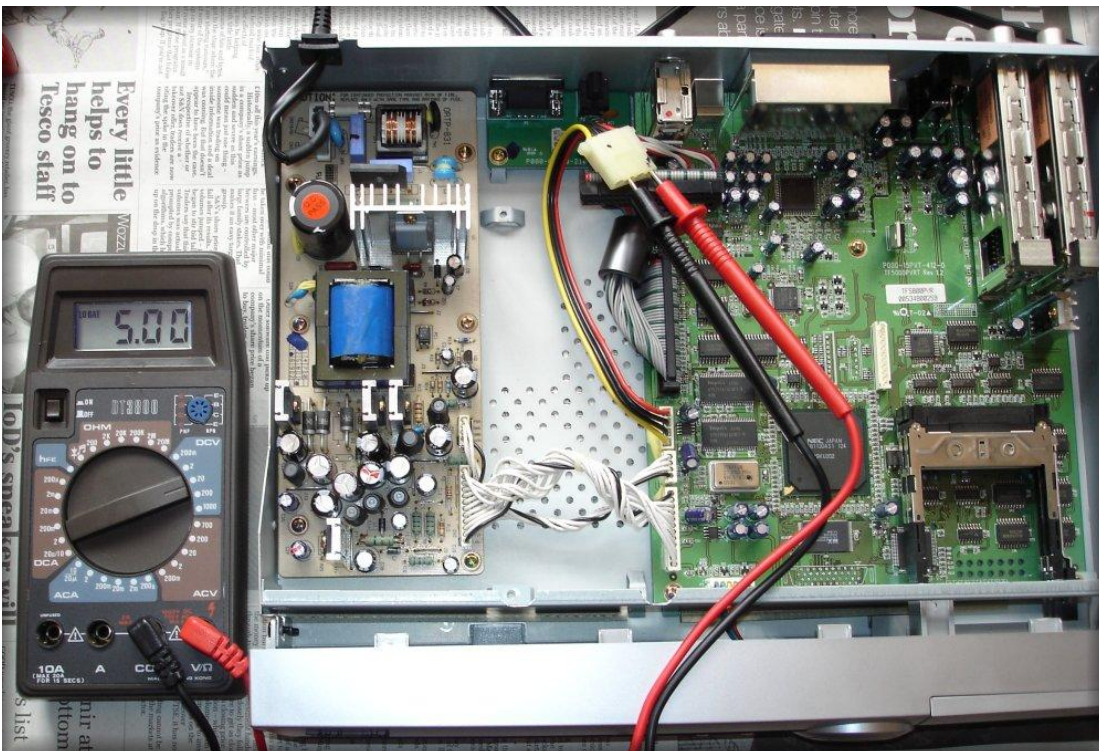
Time to test - 5v

The 5v connection looks spot-on.

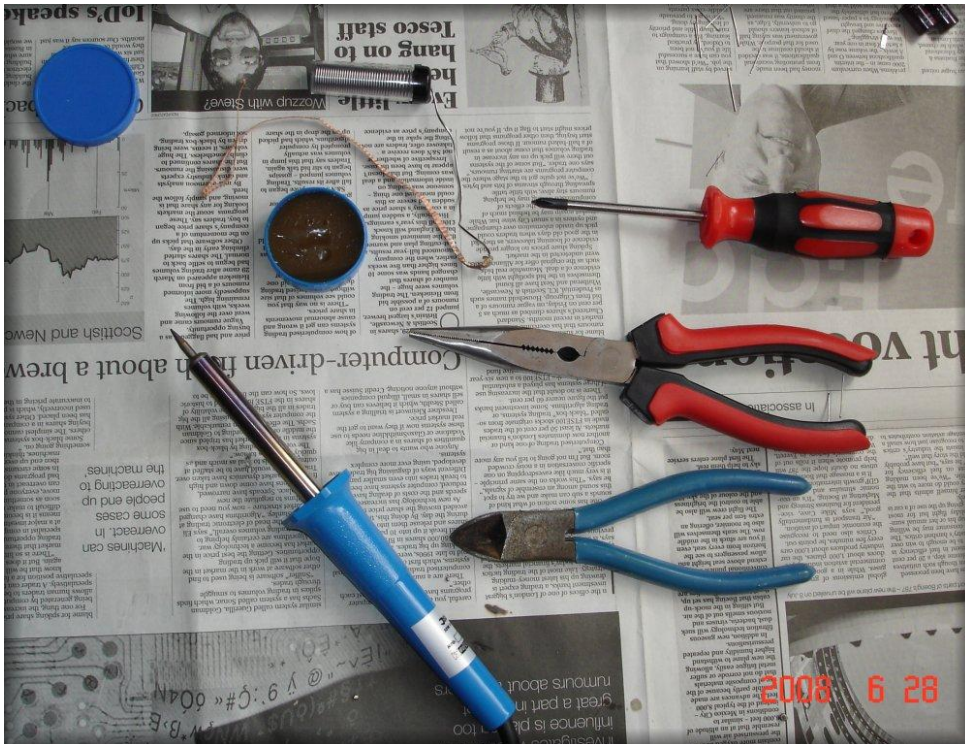
Tools

Not many tools needed. I used the long-nose pliers to gently ease out some capacitors once the solder was removed.
